RECEIVER RCA BC-348

Here I describe the restoration of an American receiver from the second world war (WWII), the RCA-BC348-R. The BC-348 was used in almost all american bomber and reconnaissance aircraft together with the transmitters BC-349 or BC-375. The receiver is wellknown and quite popular among collectors and museums.

RECEIVER RCA BC-348-R RESTORATION (March 2007 – October 2009) (DIARY)

Restored unit Belmont BC-348-R built 1943 against order 31414-WF-43 and with serial number 612.
Will be restored to its original state except for the dynamotor.

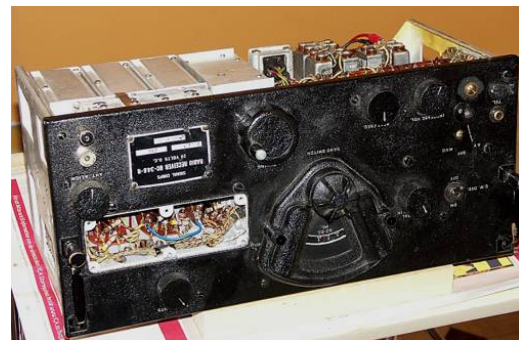
The picture shows the receiver in a typical restoration situation, upside down and with the plate covering the RF tube shelf removed. The receiver had been repainted and was a bit too shiny in some spots, but it was very good inside, almost like new! It has the older type of tubes with the top connectors and not the

later "single ended" design. The dynamotor had been replaced by a 220 V power supply, which I find to be an acceptable change for practical reasons! No other modifications were found, but the rotary switch for AVC-OFF-MVC was faulty and replaced with a DPDT switch. The output tube was a 6Y6G instead of a 6K6GT.

As usual the power supply was badly designed, so the first action was to redesign it. It had no safety grounding and no fuses (when will radio amateurs learn about safety???) , and when tested with a dummy load of 70 mA it gave 350!!! V out, the poor receiver is designed for around 220 V. The filtering was very bad, no choke or resistor, only a condenser of 16 uF! The transformer was fine and it fed a nice, classical 5Y3GT. The filament chain had been rewired for 6,3 V instead of the original 28 V and worked well.

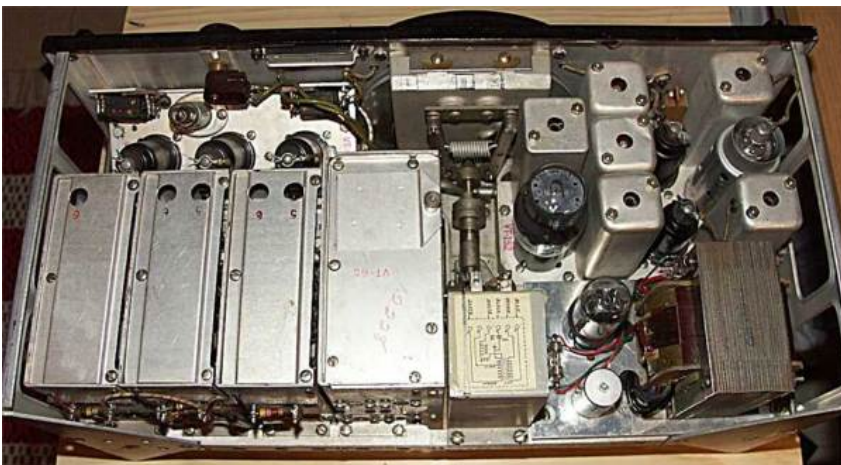
The receiver had been repainted and was a bit too shiny in some spots, but it was very good inside, almost like new! It has the older type of tubes with the top connectors and not the later "single ended" design. The dynamotor had been replaced by a 220 V power supply, which I find to be an acceptable change for practical reasons! No other modifications were found, but the rotary switch for AVC-OFF-MVC was faulty and replaced with a DPDT switch. The output tube was a 6Y6G instead of a 6K6.

As usual the power supply was badly designed, so the first action was to redesign it. It had no safety grounding and no fuses (when will radio amateurs learn about safety???), and when tested with a dummy load of 70 mA it gave 350!!! V out, the poor receiver is designed for around 220 V. The filtering was very bad, no choke or resistor, only a condenser of 16 uF. The transformer was fine and it fed a nice, classical 5Y3GT. The filament chain had been rewired for 6,3 V instead of the original 24 V and worked well.

The first action was of course to fix the power supply. Safety ground and fuses were added and the filtering was improved by adding two power resistors and one more capacitor to form double RC chains. This also decreased the voltage to 220 V at about 50 mA. I will later add some dummy load to keep the voltage down until the filaments are warm, probably a zener diode arrangement. The blown capacitor was removed, I found out it had been designed for the 24 V dynamotor input but was now connected across the 220 V HT, no wonder it had blown!!

A correct type of three way rotary switch for the AVC-OFF-MVC function was substituted for the DPDT switch repair, see photo. For safety reasons the mains was not routed over this as the 24 V was in the original, but a real mains switch, rotary, is inserted instead of the DIAL LIGHTS control.

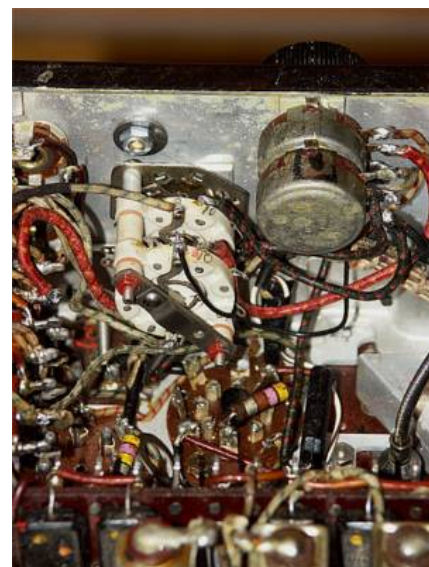
With the crystal filter OUT the bandwidth was measured to around 5.6 kHz (+- 2.8 kHz) @ - 3 dB and around 14 kHz (+- 7 kHz) @ - 20 dB. With the crystal filter IN the bandwidth was 400 Hz (+- 200 Hz) @ - 3 dB and 3 kHz (+- 1.5 kHz) @ - 20 dB (specified to +- 2 kHz).

A 1 mV ptp signal from a signal generator tuned to the receiver intermediate frequency 915 kHz was connected to the mixer grid with a 100 nF capacitor. The signal was modulated to 30 % with 400 Hz. The frequency was varied and the output was measured at the headphone output.

First the frequency of the crystal filter was checked to be 915.00 kHz. All IF circuits were then aligned to that frequency, the output increased nearly 20%.

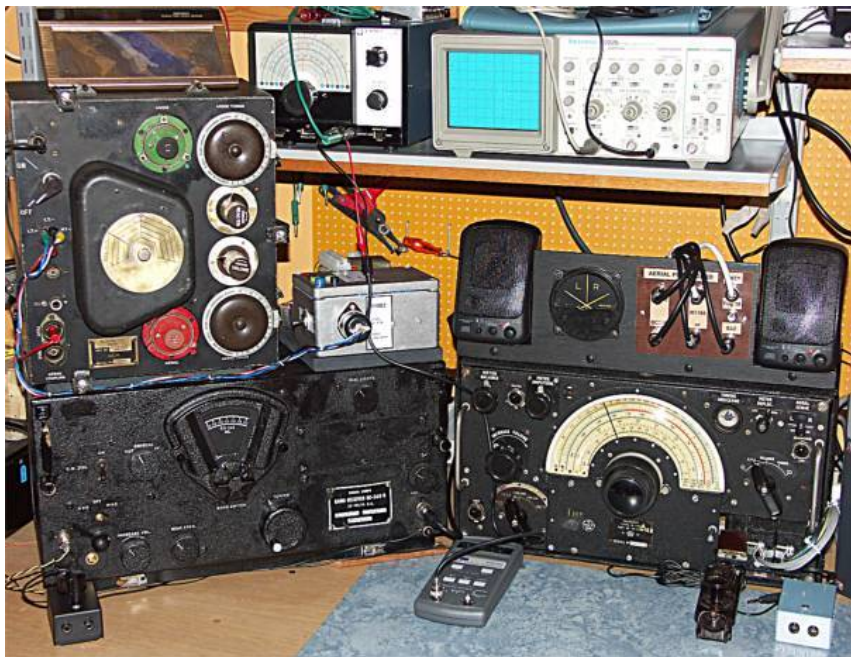
My BC-348-R in its collector environment! It remains to repair band 2 and to repaint the front panel.

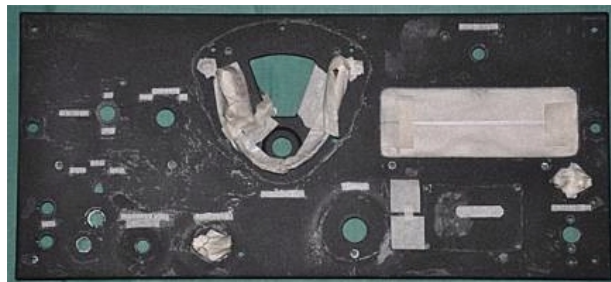
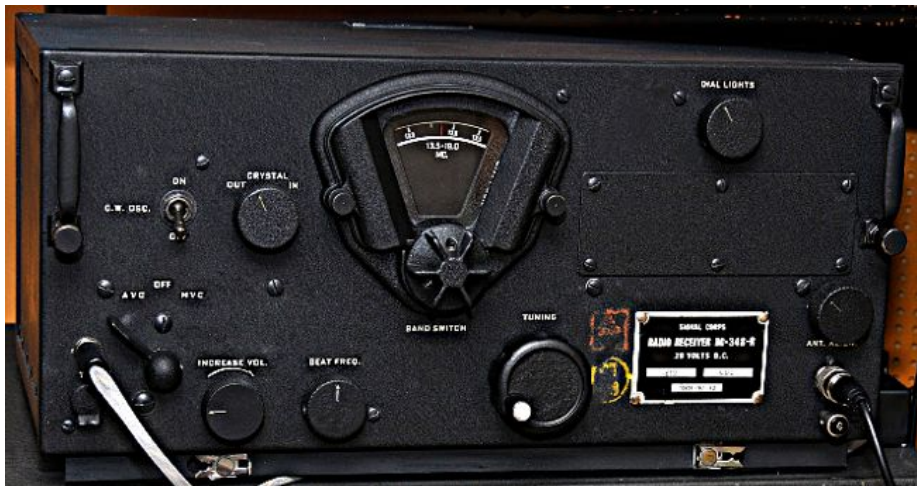
My restored BC-348-R receiver

The plastic identification plate was original but in bad shape with paint and pieces missing. The paint on the back of the plastic sheet was retouched and the plastic sheet was then glued to a thin white aluminum plate. Missing pieces were replaced. The identification plate now looked fairly good and was riveted in place.

Two service stamps to the left of the plate were taped during the paint process and thus saved.

The front panel was removed and the text masked with tape. The outer layer of paint was removed with a chemical paint remover, applied in very thin coats. The underlying wrinkle paint structure was thereby saved. Finally the panel was sprayed with two thin coats of mat black paint.

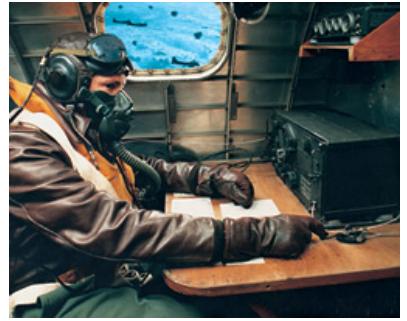
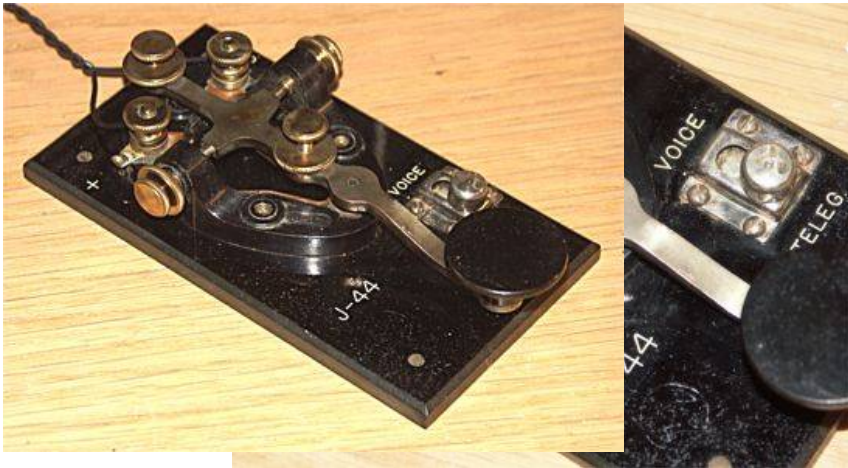
The key was of course wired to the transmitter BC349 or BC375, but it was sitting on the table in front of the radio operator with the receiver. I bought the key to resemble the operator environment.

The J44 key is 13 cm x 7 cm. The J37 is very nice to operate and still popular with radio amateurs.

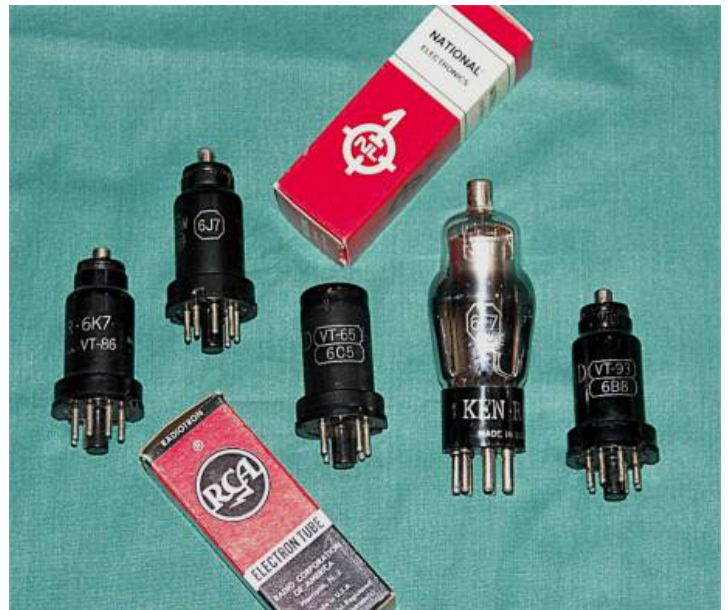
Spare valves

The valves used in the BC-348-R are:
3 each 6K7 (first and second RF and first IF)
1 each 6C5 (oscillator)
1 each 6J7 (mixer)
1 each 6F7 (second IF and beat oscillator)
1 each 6B8 (third IF, detector, AVC)
1 each 6K6GT (AF stage)
1 each 991 (voltage regulator)

Most of the valves are metal types with octal base and top connector.

I have bought a set of spare valves, one of each type, from Radio Daze, link 2. The valves are NOS (new old stock), not used but of old manufacture and in original boxes.

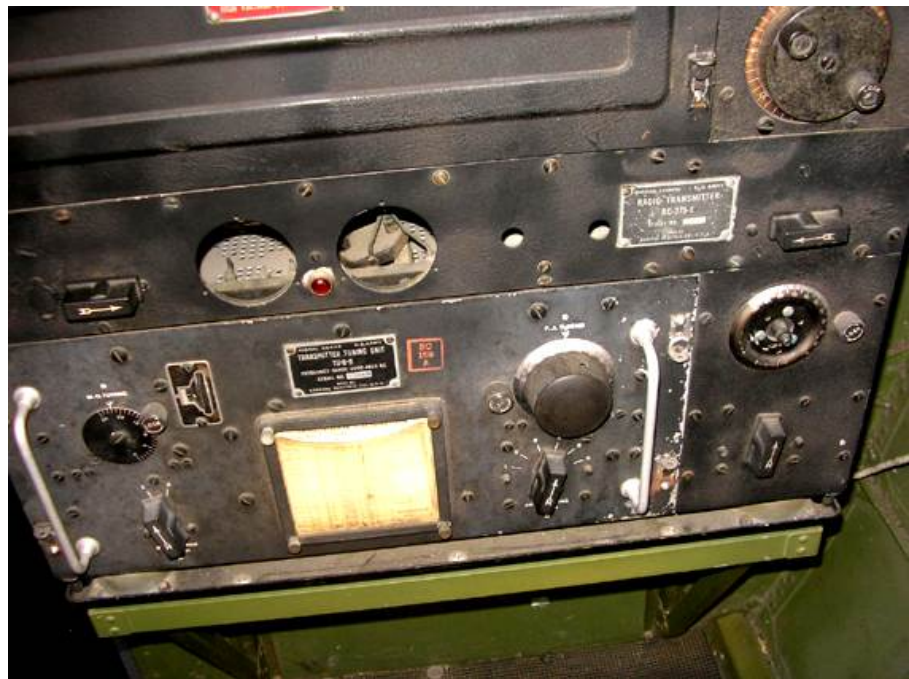
The transmitter BC-349 which was used together with the BC-348 receiver for HF communication with the home bases. Here in the Aluminum Overcast.

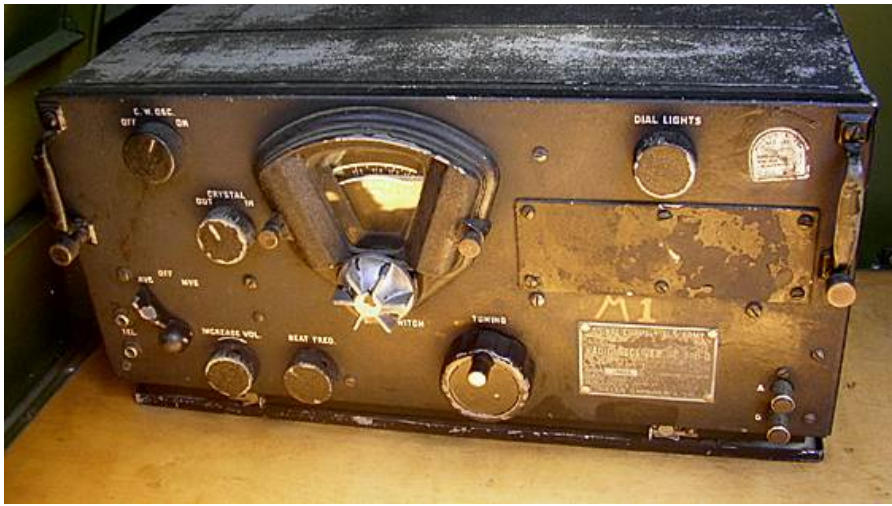
This BC-348 receiver seems to have been in service.

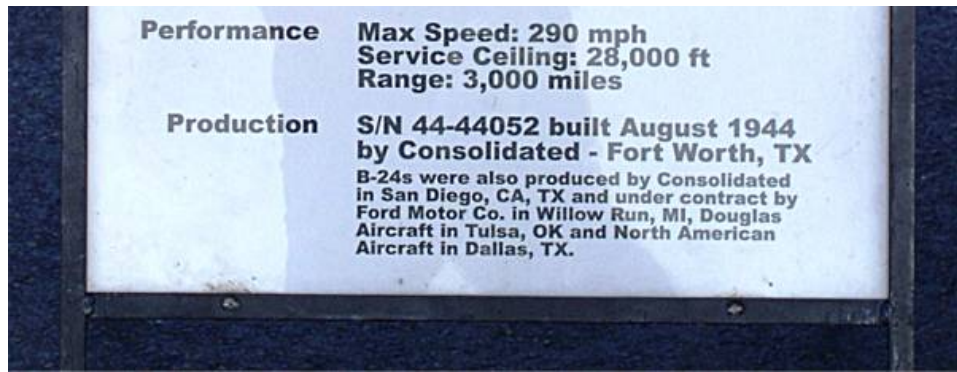
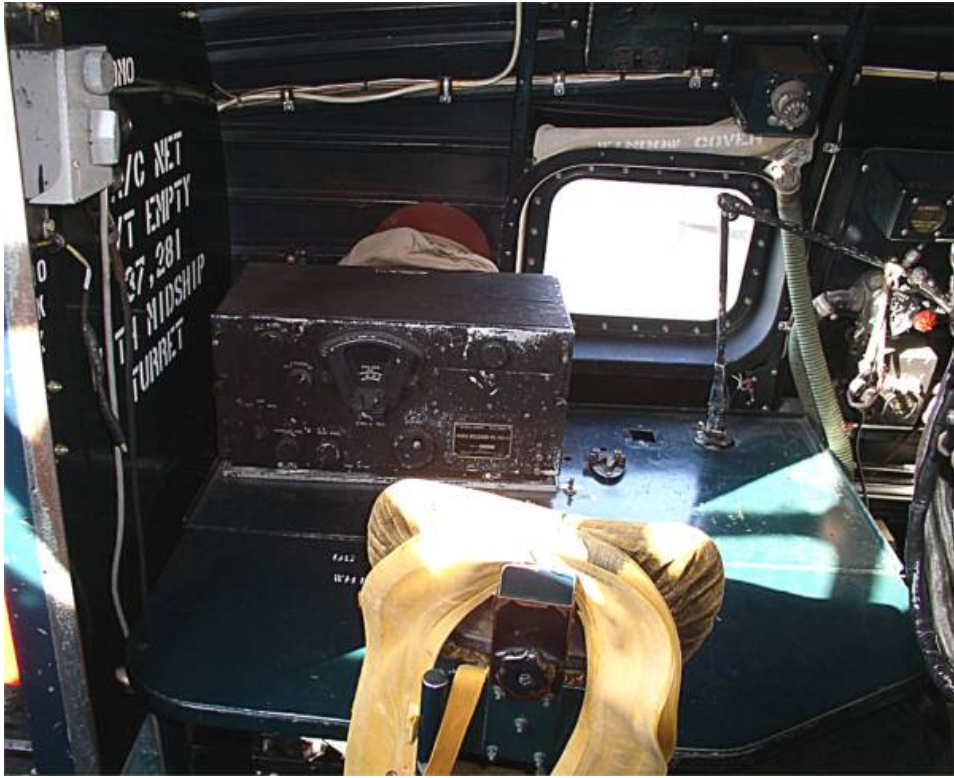
The receiver BC-348-N built by Wells Gardner seems to have been heavily used!

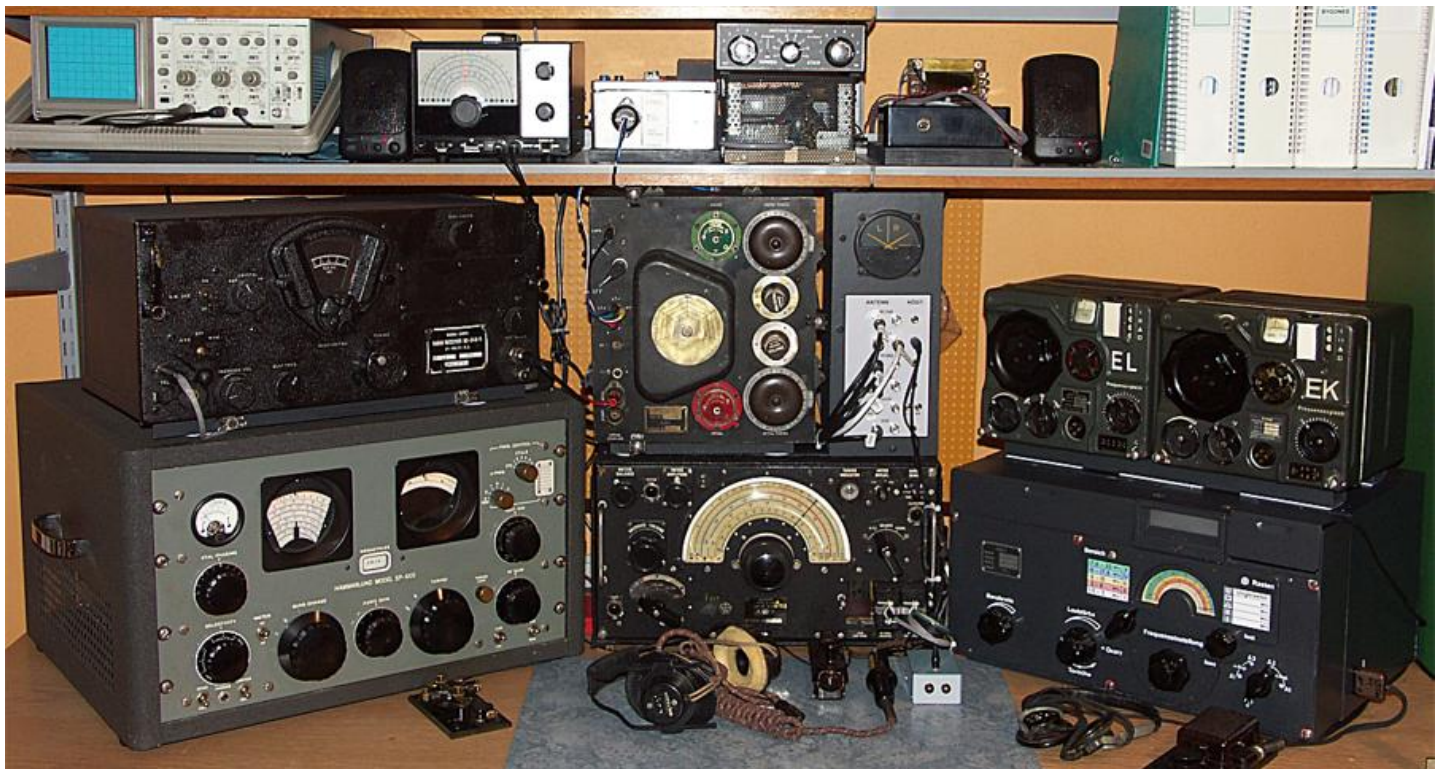
My restored BC-348-R in my little collection of receivers from WWII (before repainting the panel).

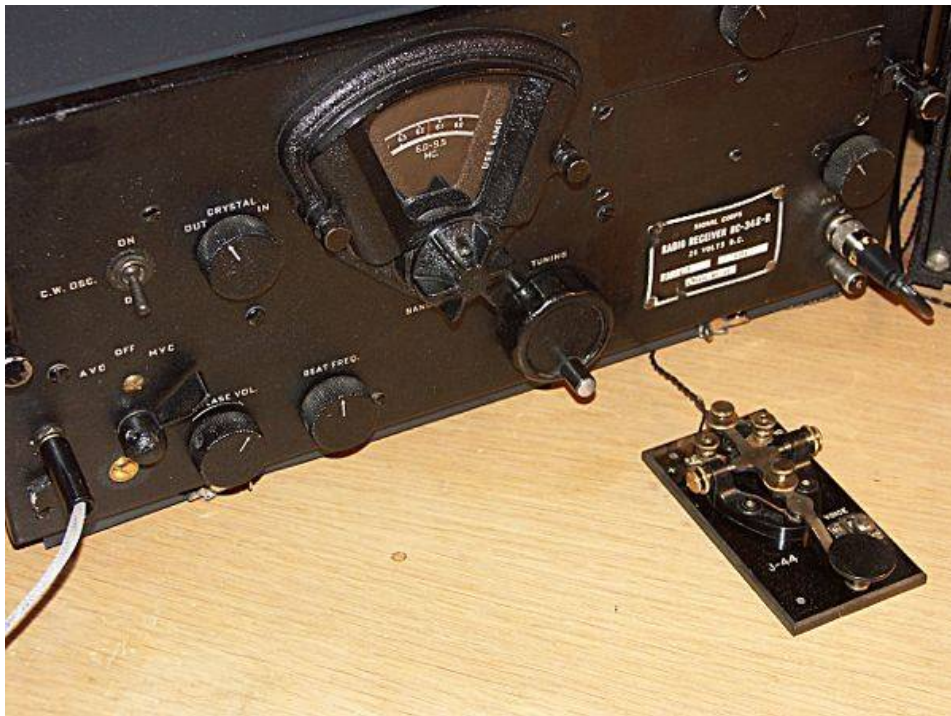
My BC-348-R with the J-44 key (before repainting the panel). The key is connected to a morse training oscillator.

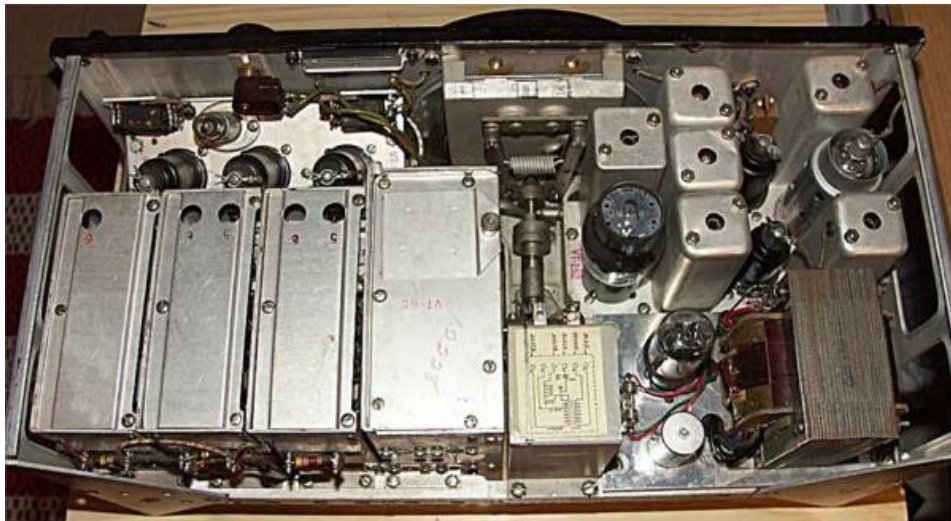
The receiver is like new inside, except for the dynamotor.

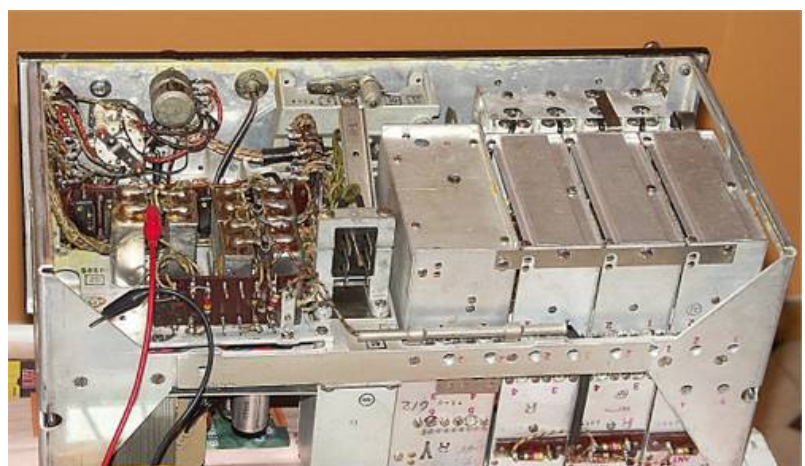
The receiver seen from back/below. Most components are soldered to pertinax strips.

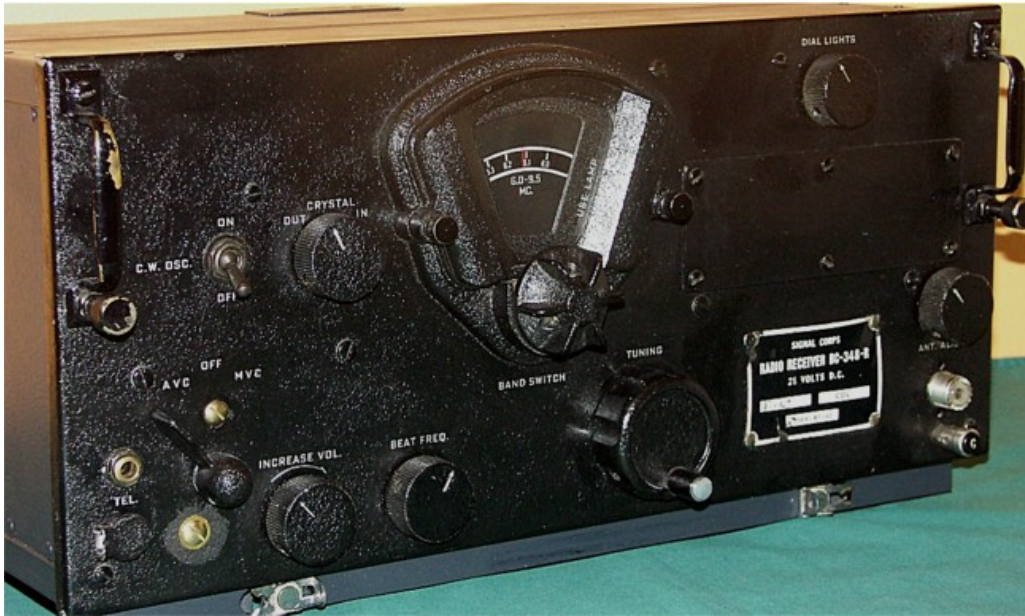
Last photos:
The receiver before repainting the panel. The service stamps to the left of the type plate are covered with paint and the type plate is tattered. The paint is applied in thick coats and with shining spots.

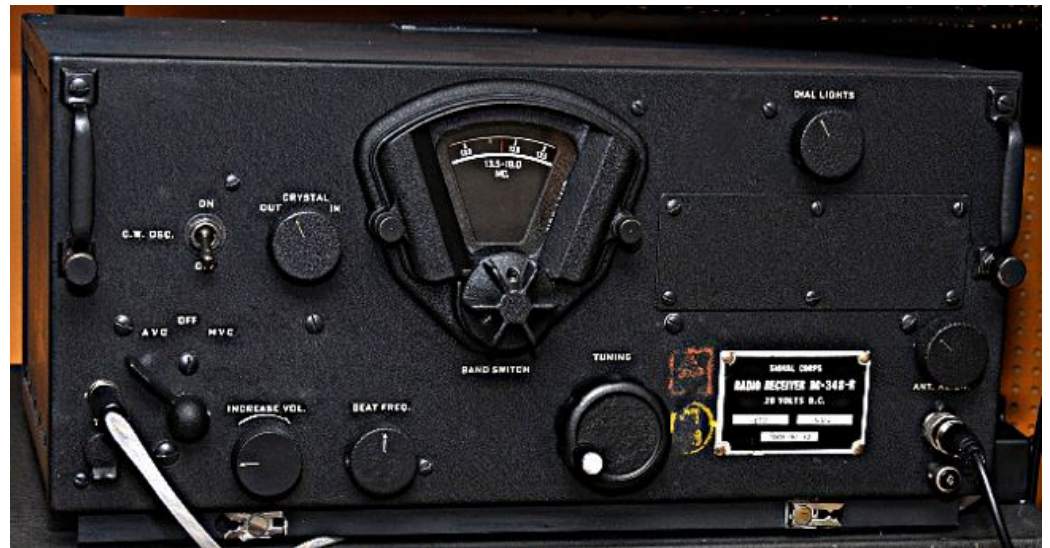
The completely restored receiver. The service stamps are now visible and the type sign mended. The receiver has the original mat black paint.
